Changes in the Depth of the Lower Charles River Basin

Carl Zimba, Charles River Alliance of Boaters, Belmont, MA (zimba.carl@gmail.com)
Michael J. Sacarny, MIT Sea Grant College Program, Cambridge, MA (msacarny@mit.edu)
Madonna Yoder, MIT Sea Grant College Program, Cambridge, MA
Ben Bray, MIT Sea Grant College Program, Cambridge, MA and
Chrysostomos Chrysostomidis, MIT Sea Grant College Program, Cambridge, MA

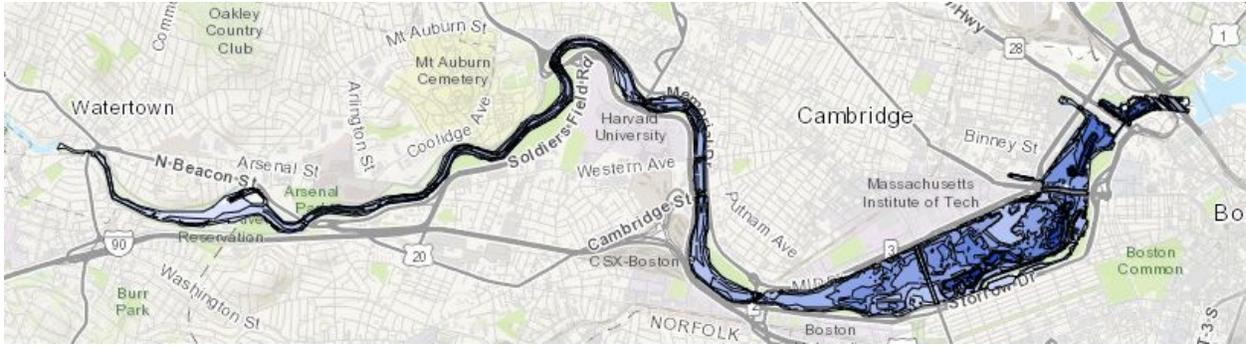
The measured depth chart [Figure 1] is available to the public in various formats including a GIS map, a Google map, a KMZ file suitable for Google Earth and some navigation instruments, a chart booklet similar to that published by NOAA, and a wall chart.²

Figure 1. Depth Chart of the Lower Basin of the Charles River. This can be viewed in detail at <https://mit.sea-grant.net/maps/charleschart/>.

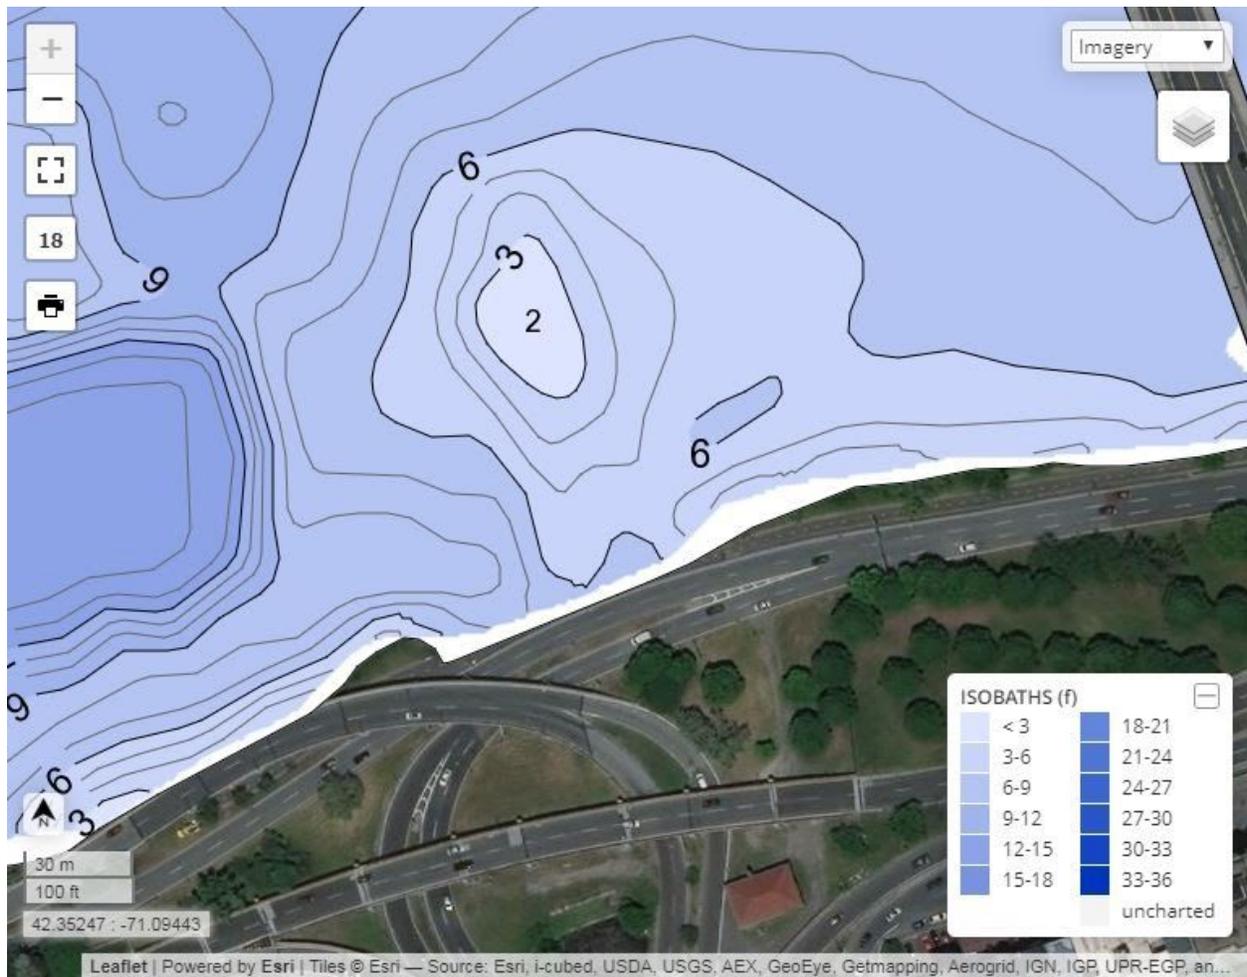
This is a broad and shallow delta-like feature approximately 150 feet north of the outflow culverts for the Muddy River and Stony Brook [Figure 2]. The shallowest area is 1-2 feet below the water surface and is firm enough to walk on. Sample dredging indicates that the material is fine stone and sand. While shallow enough to be a hazard to navigation, it is in an area of the river that is not used by the typical user and does not pose a hazard to the informed user. It was initially discovered by the Boston University sailors when they went aground on it more than 15 years ago. The current state is quite similar to what existed in 1946,⁶ prior to the dredging⁷ of a trench 700 feet long, 50-75 feet wide, and 11 feet deep, perpendicular to the shore from near the Fens Gate House.

Figure 2. Depth Chart of Charles River near the outflow of Muddy River and Stony Brook.

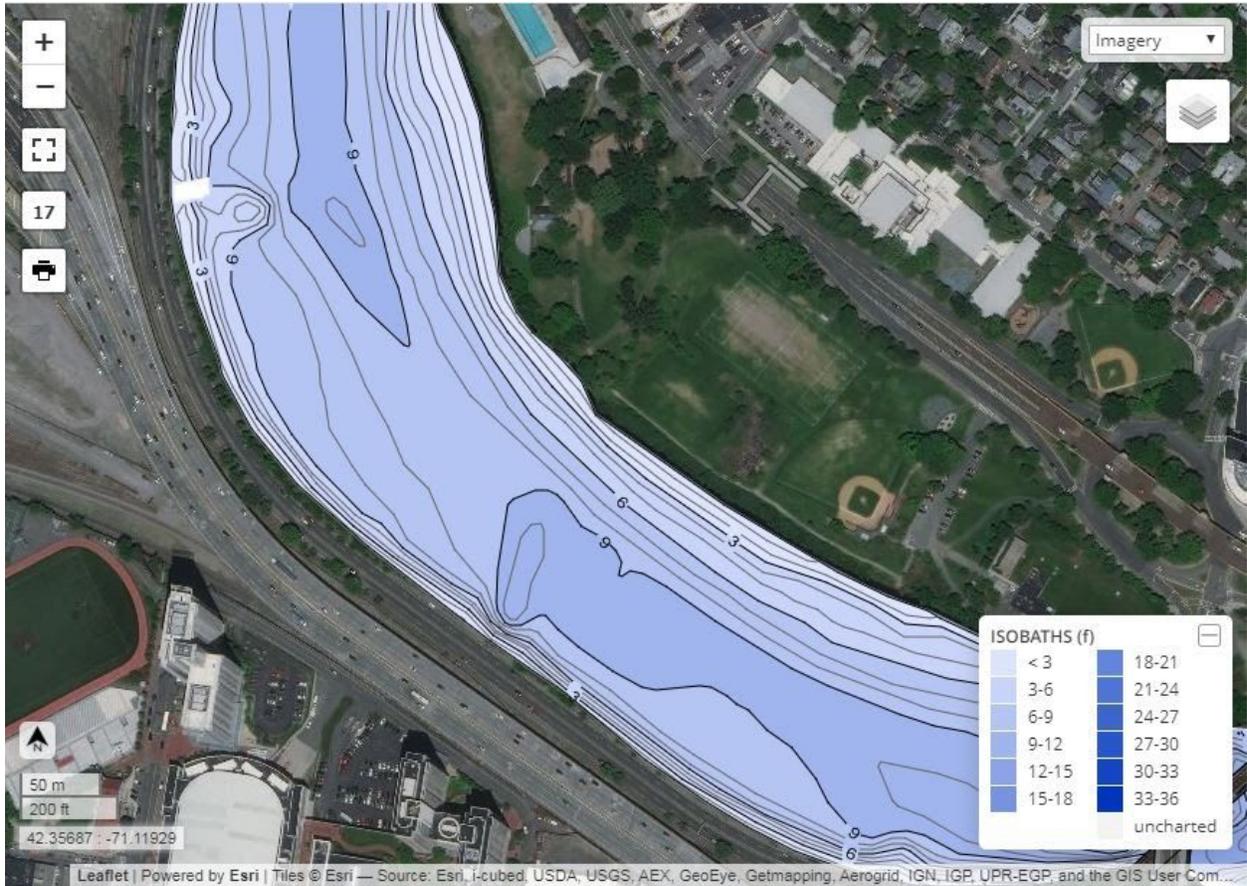
There is a shallow region spanning the entire width of the river in the area of Magazine Beach [Figure 3], near the proposed realignment of I-90 and Soldiers Field Road in Allston. Compared to an engineering survey done in 1920^{8,9} for a potential bridge connecting Magazine Street in Cambridge to St. Paul Street in Boston, it appears that the area is 4-6 feet shallower now than in 1920. While the current water depth in this area has not hampered use of the water sheet, the depth is likely continuing to decrease. Future monitoring of the water depth in this area is warranted.

Figure 3. Depth Chart of Charles River near Magazine Beach.

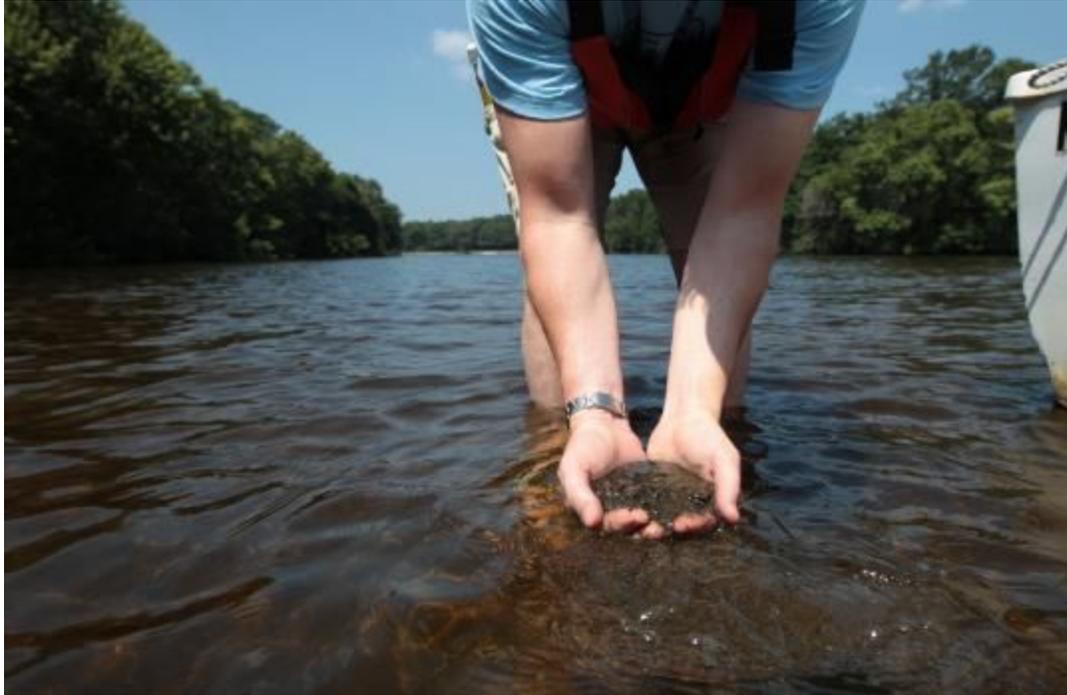
Faneuil Brook empties in the Charles River on the south bank between the Arsenal St and North Beacon St bridges. Over the last few decades, a significant bar formed that reduced in half the width of the river. While much of the bar was just below the water surface, presenting a significant hazard to the typical boater, the bar could also become exposed when water levels were low water [Figure 4]. Due to the narrowness of the river, this sandbar was the cause of several collisions and groundings involving damage to boats and injury to people. Fortunately, two years ago, this bar was dredged, restoring the river depth and eliminating the safety dangers that the sandbar was causing. This outfall was dredged previously in 1921¹⁰ and 1936¹¹. Dredging was contemplated but not done in 1954¹², 1965¹³, and 1976¹⁴. This area was dredged to restore the depth to the surrounding river bottom in 2016¹⁵. There seems to have been some refilling of this dredged area four years later. This outfall will need to be periodically dredged in the future, as it has over the past 100 years.

Figure 4. Faneuil Brook sandbar. [I'm looking for a better picture. This one may be copyrighted by the Globe.]

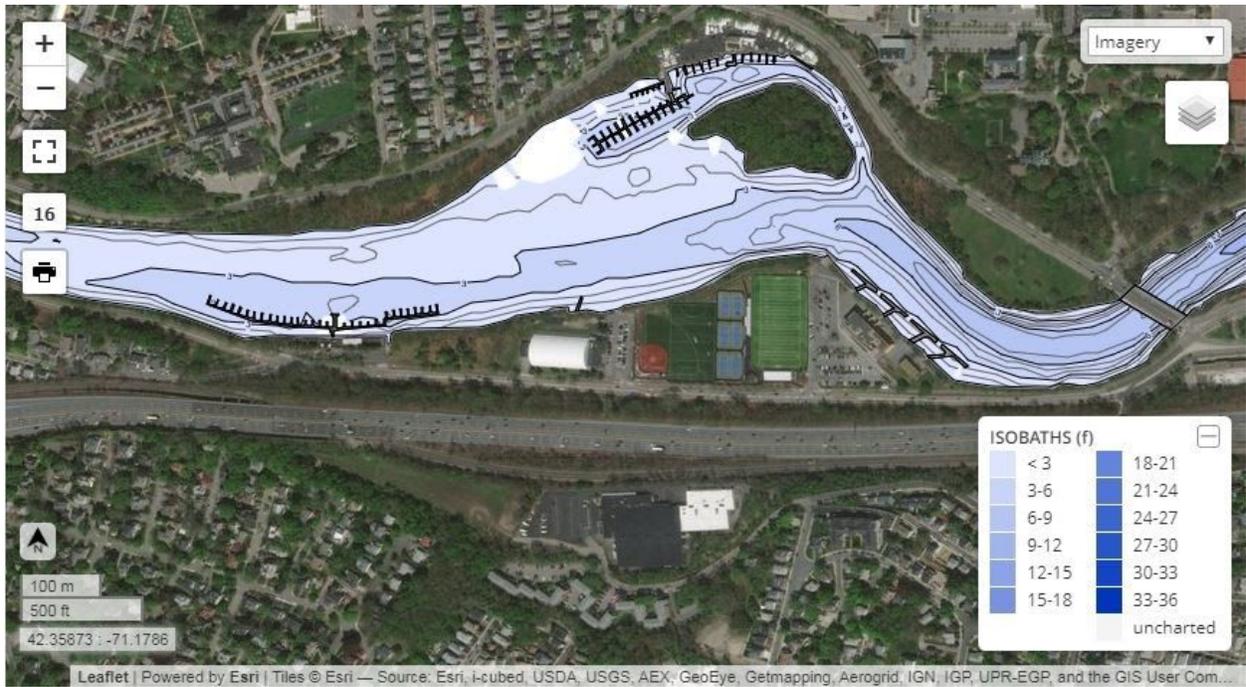
The most threatened area for sedimentation is Sunset Bay [Figure 5], the area west of the North Beacon St. Bridge where Community Rowing, Watertown Yacht Club, and Newton Yacht Club are. Today, much of the area is 2 feet deep or less, with a narrow channel of 3-4 feet depth. A vast portion of the area between Newton Yacht Club, Watertown Yacht Club, and Community Rowing is too shallow for motorized vessels to pass safely. Both Watertown and Newton yacht clubs have already lost dock space due to the sedimentation and some boaters are unable to move their boats if the water level of the water sheet is lower than average. There has also been quite a bit of sedimentation under the docks of Community

Rowing, especially at the western end near the boat ramp. Docks at Community Rowing that used to be in 2 feet of water when built in 2008 are now resting on mud.

The sedimentation cited in the Cortell and Associates report has continued over the ensuing years, 1997 to 2018, as measured in our depth studies. The areas near Newton and Watertown Yacht Clubs have continued to lose depth and the areas of usable depth have shrunk. The dense plant growth has continued and spread as the shallower areas have grown. The up-river docks at Community Rowing that were in 18-24 inches of water when the new boathouse was opened in 2008 are now resting on mud and silt. Sedimentation in this area is a threat to the future of both yacht clubs and Community Rowing.

Figure 5. Depth Chart of Charles River near Sunset Bay. Watertown Yacht Club is the north side of the river, between the island and the main shore. Newton Yacht Club is on the south side of the river on the left (west) half of this image. Community Rowing is on the south side of the river, on the right (east) side of this image. North Beacon Street Bridge is located on the far right.

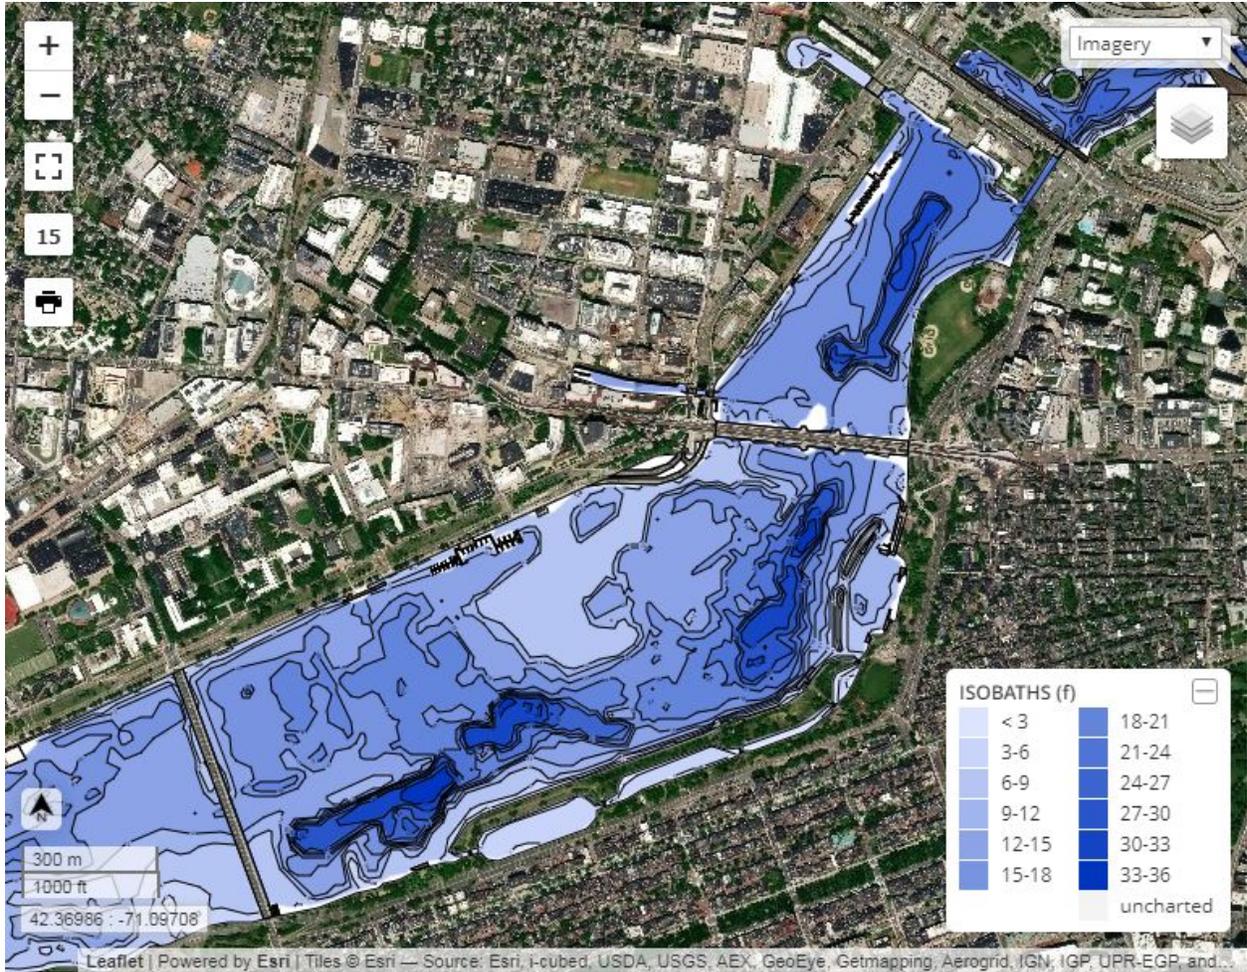
In the Sailing Basin between the Harvard (Massachusetts Avenue) Bridge and the Longfellow Bridge, there are four trenches with depths between 20 and 30 feet [Figure 6]. These trenches were not present in the detailed survey of 1902²⁸ and were created through dredging during the expansion of the Boston Esplanade in the 1930's and 1950's. It has been well-documented that some salt water travels from Boston Harbor into the river through the locks of the dam and that this denser salt water tends to sink to the lowest depths of the river basin and not mix with the overlying fresh water layer.²⁹ In addition, the salt water layer becomes oxygen depleted and does not allow the natural decomposition of plant matter on the river bottom to occur, resulting in a sulfurous-smelling muck on the river bottom. While the New Charles River Dam was designed to minimize the influx of sea-water, salt water still is introduced to the river with much of it becoming trapped in the deep water trenches. The influx of the sea water is seasonal, high in the summer season when recreational boats passing through the lock is highest and quite low in the winter when the lock is seldom used. High flows of fresh water from precipitation and runoff during and following storms cause the salt water to flush out of the river basin.²⁹ An open question is the influence of the deep trenches on the flushing of the salt water. Would the salt water be flushed out more effectively if the trenches were filled? Or would the salt water remain and merely be spread out over a larger area of the river bottom?

Figure 6. Man-made trenches in Charles River between the Harvard Bridge and the Charles River Dam.
