Lower Charles River Chart

CRAB and MIT Sea Grant Chart Project

Introduction to the Chart Project

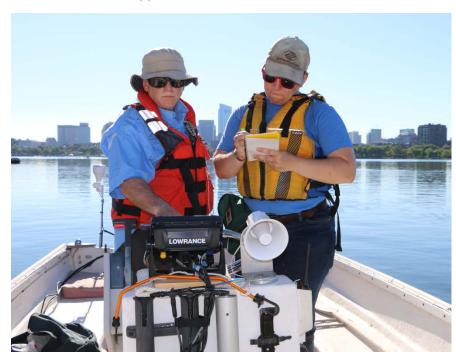
Sacarny and Yoder on Charles during survey. Note GPS visible above transom.

The project team used a Lowrance HDS-7 chartplotter/fishfinder with Point-1 GPS, HST-WSBL broadband, and LSS-2 sidescan sonar transducers for depth measurements. In areas of the river that are wide, survey lines were spaced between 30 and 65 feet apart and driven at speeds generally between 3 and 4.8 knots. Where the river is narrow, several passes were made up and down the river over multiple weeks. Broadband sonar was used during the entire survey, resulting in recordings of both depth and relative hardness of the river bottom, as well as time and position of each sonar reading. In addition, sidescan sonar was used downriver of the BU Bridge to capture images of the river bottom and objects of interest.
