MIT Sea Grant publication number 17-01

Introduction to the Chart Project

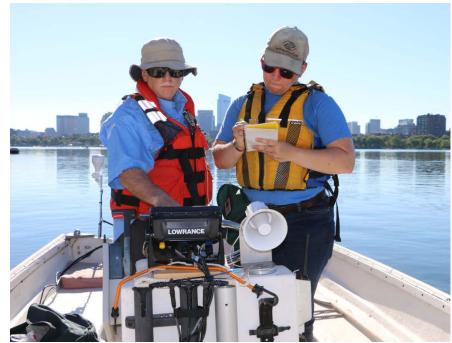
Sacarny and Yoder on Charles during survey. Note GPS visible above transom.

The project team used a Lowrance HDS-7 chartplotter/fishfinder with Point-1 GPS, HST-WSBL broadband, and LSS-2 sidescan sonar transducers for depth measurements. In areas of the river that are wide, survey lines were spaced between 30 and 65 feet apart and driven at speeds generally between 3 and 4.8 knots. Where the river is narrow, several passes were made up and down the river over multiple weeks. Broadband sonar was used during the entire survey, resulting in recordings of both depth and relative hardness of the river bottom, as well as time and position of each sonar reading. In addition, sidescan sonar was used downriver of the BU Bridge to capture images of the river bottom and objects of interest.
