MIT Sea Grant publication number 17-01

Introduction to the Chart Project

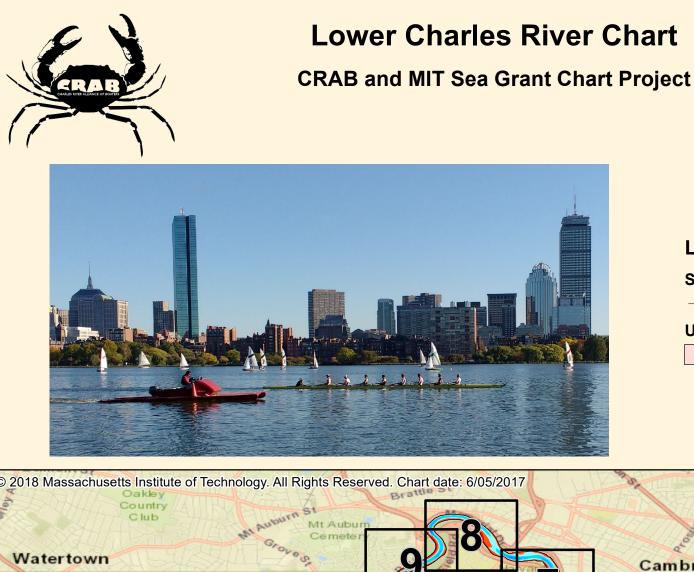
Legend Shorelines Depth (ft) 0-3 18-21 **Uncharted Areas** 3-6 21-24 24-27 6-9 9-12 27-30 12-15 30-33 33-36 15-18

In order to more accurately determine the depth of the river, all raw depth measurements have been adjusted to account for the variation in the height of the watersheet, and referenced to a First Street Bridge gauge height of 107.5 ft.

Vertical Uncertainty: This chart represents depths as determined by fishfinder sonar and is based on echo from the top layers of sediments. Given these readings, transducer uncertainty, and related factors, the depth accuracy is stated as +/-5%. In areas of loose sediments, manual measurements could result in depths several tenths of a foot greater than those based on fishfinder sonar.

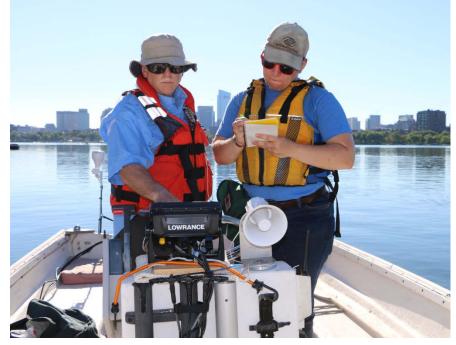
Sacarny and Yoder on Charles during survey. Note GPS visible above transom.

The project team used a Lowrance HDS-7 chartplotter/fishfinder with Point-1 GPS, HST-WSBL broadband, and LSS-2 sidescan sonar transducers for depth measurements. In areas of the river that are wide, survey lines were spaced between 30 and 65 feet apart and driven at speeds generally between 3 and 4.8 knots. Where the river is narrow, several passes were made up and down the river over multiple weeks. Broadband sonar was used during the entire survey, resulting in recordings of both depth and relative hardness of the river bottom, as well as time and position of each sonar reading. In addition, sidescan sonar was used downriver of the BU Bridge to capture images of the river bottom and objects of interest.
